# Emergency Response Mapping of Surge Flooding and Damage to Coastal Resources with Satellite Radar and Optical Data

# Flood Inundation during Hurricane Isaac derived from TerraSAR-X scene data

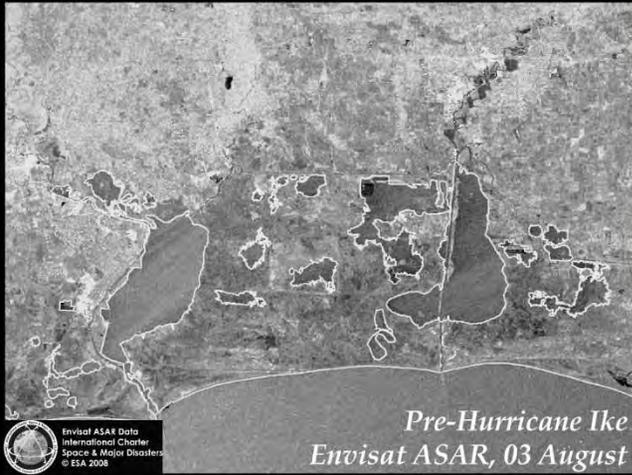
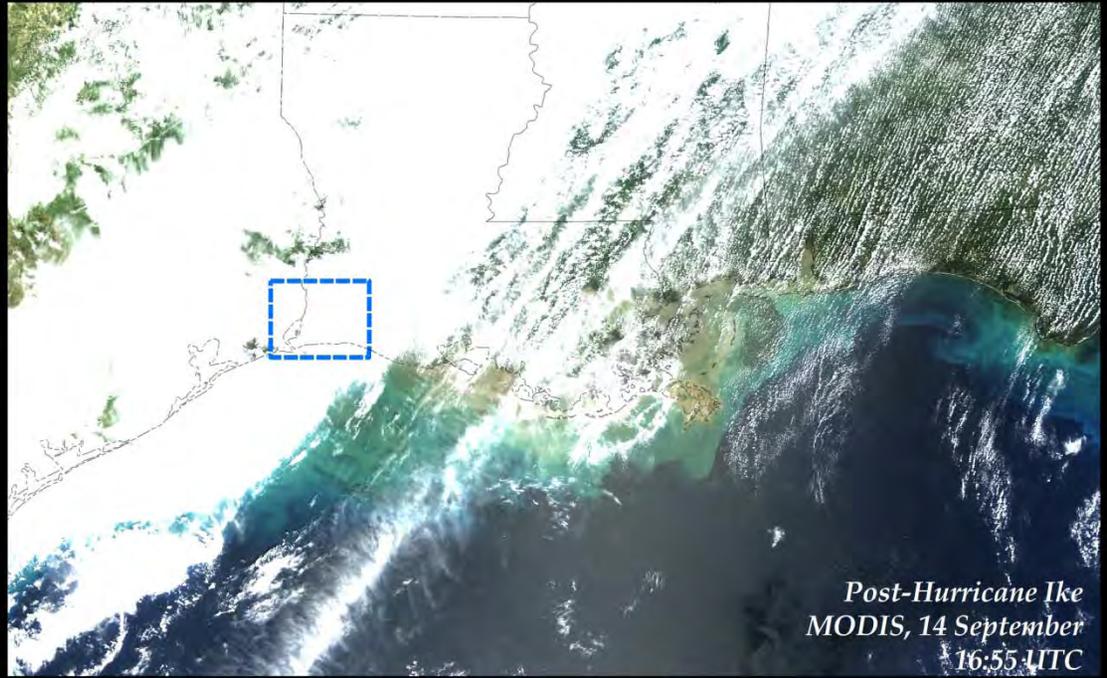
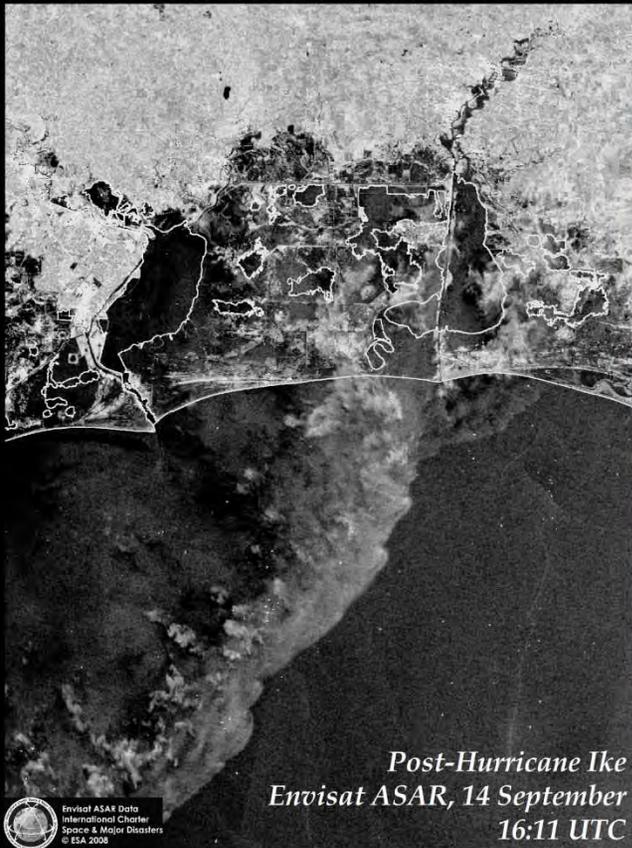
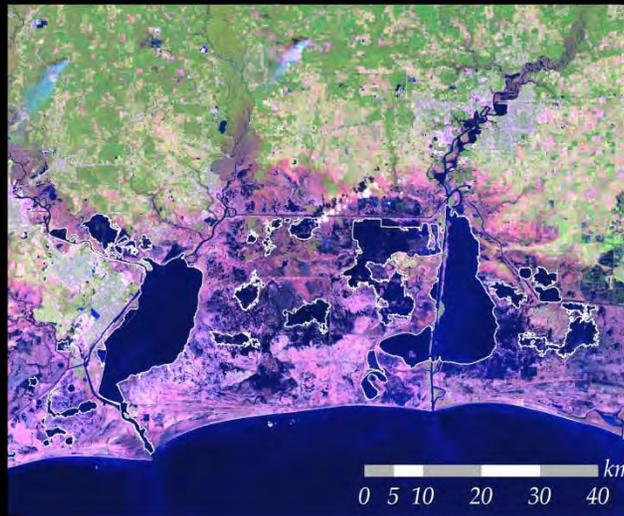
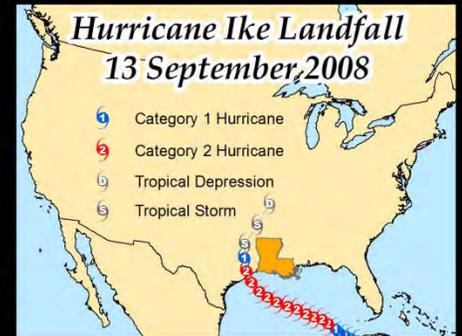
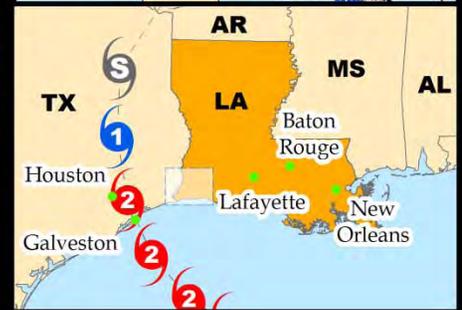
A rare example of the synergistic application of optical and radar satellite imagery in an emergency response situation encountered during and after the landfall of Hurricane Ike at Galveston, Texas, on 13 September 2008 (Ramsey III, E., D. Werle, Z. Lu, A. Rangoonwala, and Y. Suzuki, 2009. Cover graphic, *Journal of Coastal Research*. 25(5)). The overpass of the European Envisat satellite on 14 September offered immediate acquisition of Advanced Synthetic Aperture Radar imagery that provided an unobstructed view of the impacted area (owing to the cloud-penetrating capability of radar), and thereby, critical information for human rescue efforts. In contrast, optical imagery would not have provided the same efficiency or quality of information for rescue operations. For example, the dense and extensive cloud cover visible on the Moderate Resolution Imaging Spectroradiometer (MODIS) image precluded the effective use of optical satellite imagery for relief operations. In terms of environmental monitoring, however, optical satellite imagery offers important information that can be combined with radar imagery to provide a more complete understanding of environmental impacts. For instance, optical imagery acquired on 29 September 2008 by the Landsat-5 Thematic Mapper (TM) reveals an area of sudden marsh dieback (purplish tone) that coincides with the surge flood extent (dark tone) substantiated by comparison of the post-hurricane 14 September and pre-hurricane 3 August 2008 ASAR images.

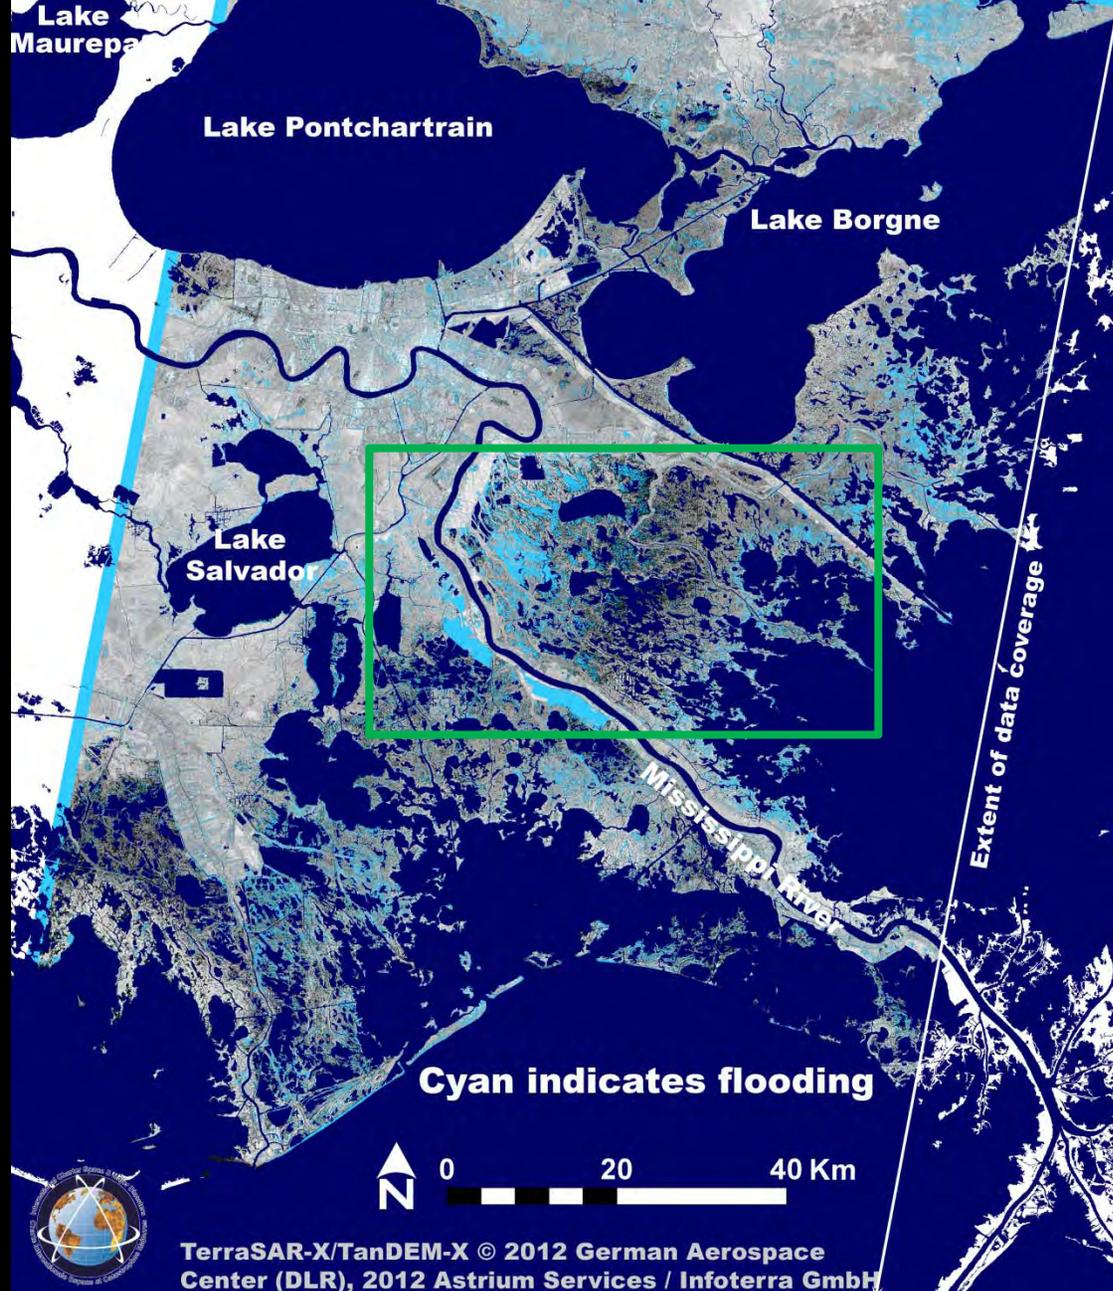
# Flood Inundation during Hurricane Isaac based on TerraSAR-X September 4, 2012 and September 2, 2008 data

Cyan indicates flooding

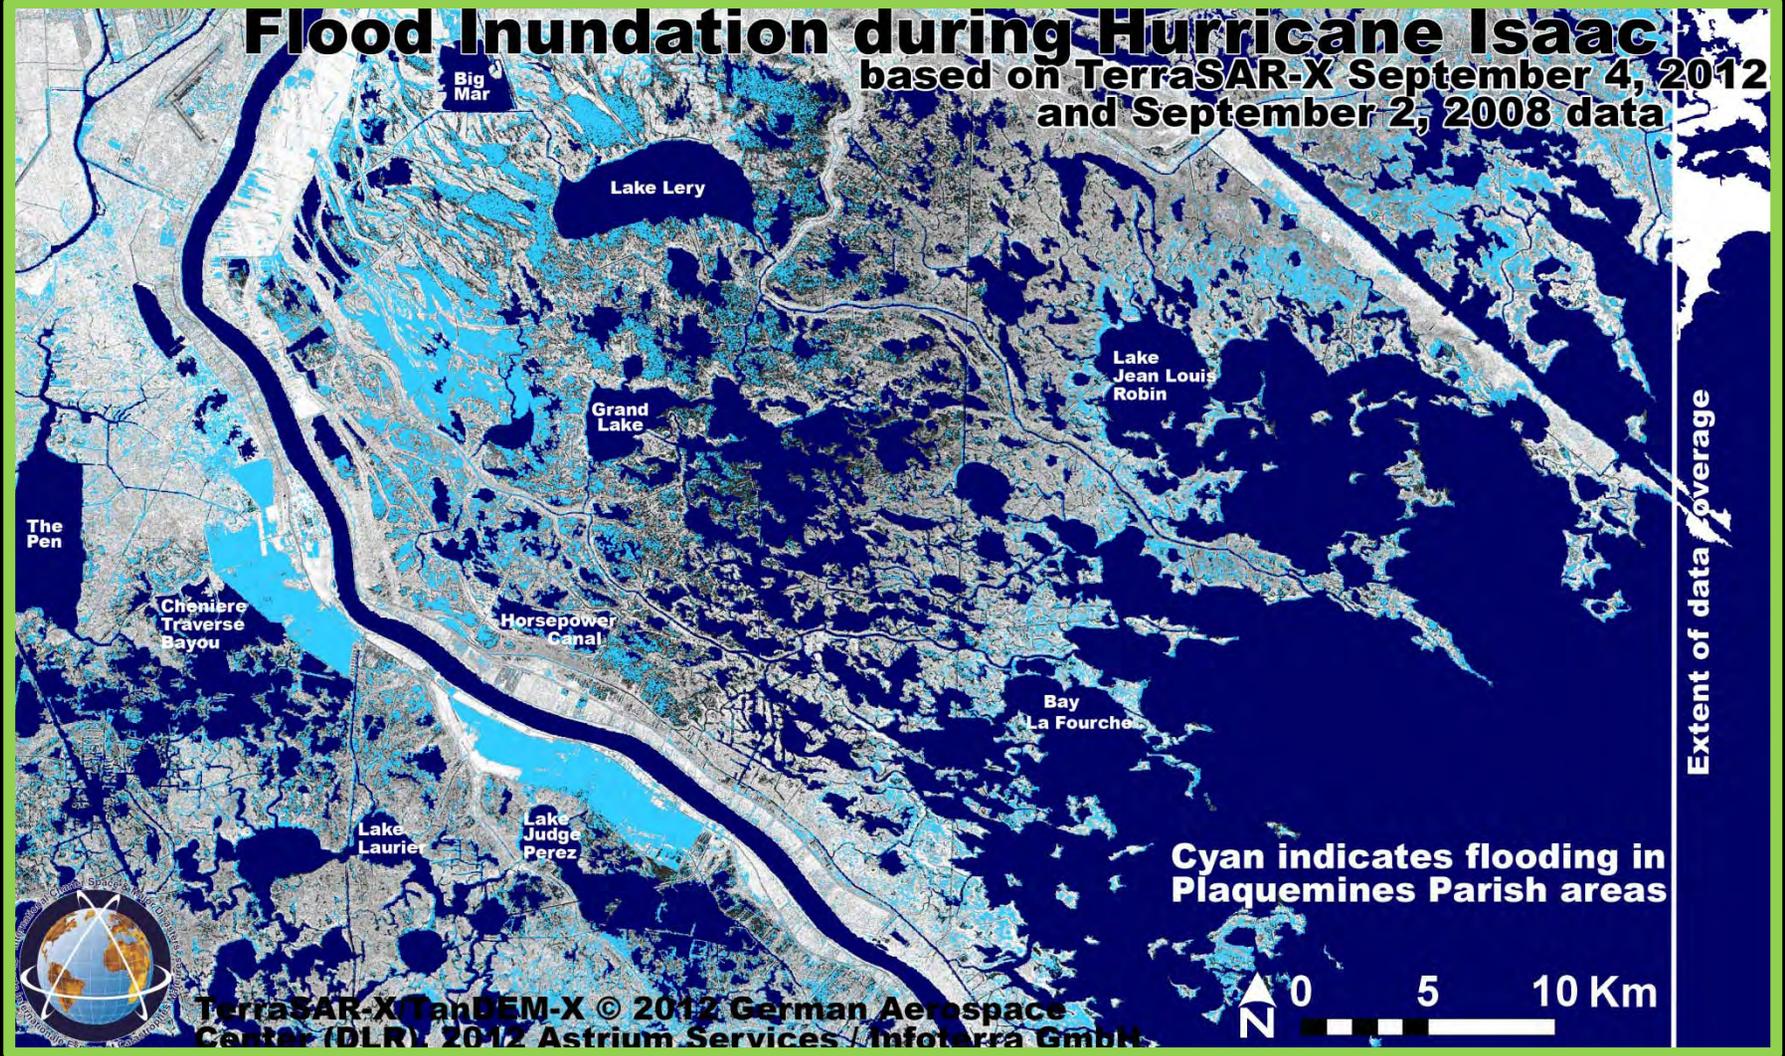
# Flood Inundation during Hurricane Isaac

based on TerraSAR-X September 4, 2012  
and September 2, 2008 data
