# Impacts of Hurricane Mitch on Water Quality and Sediments of Lake Izabal, Guatemala

By Thomas C. Michot, Ronald G. Boustany, Alexandro Arrivillaga, Brian Perez

USGS Open File Report  
OFR 03-180

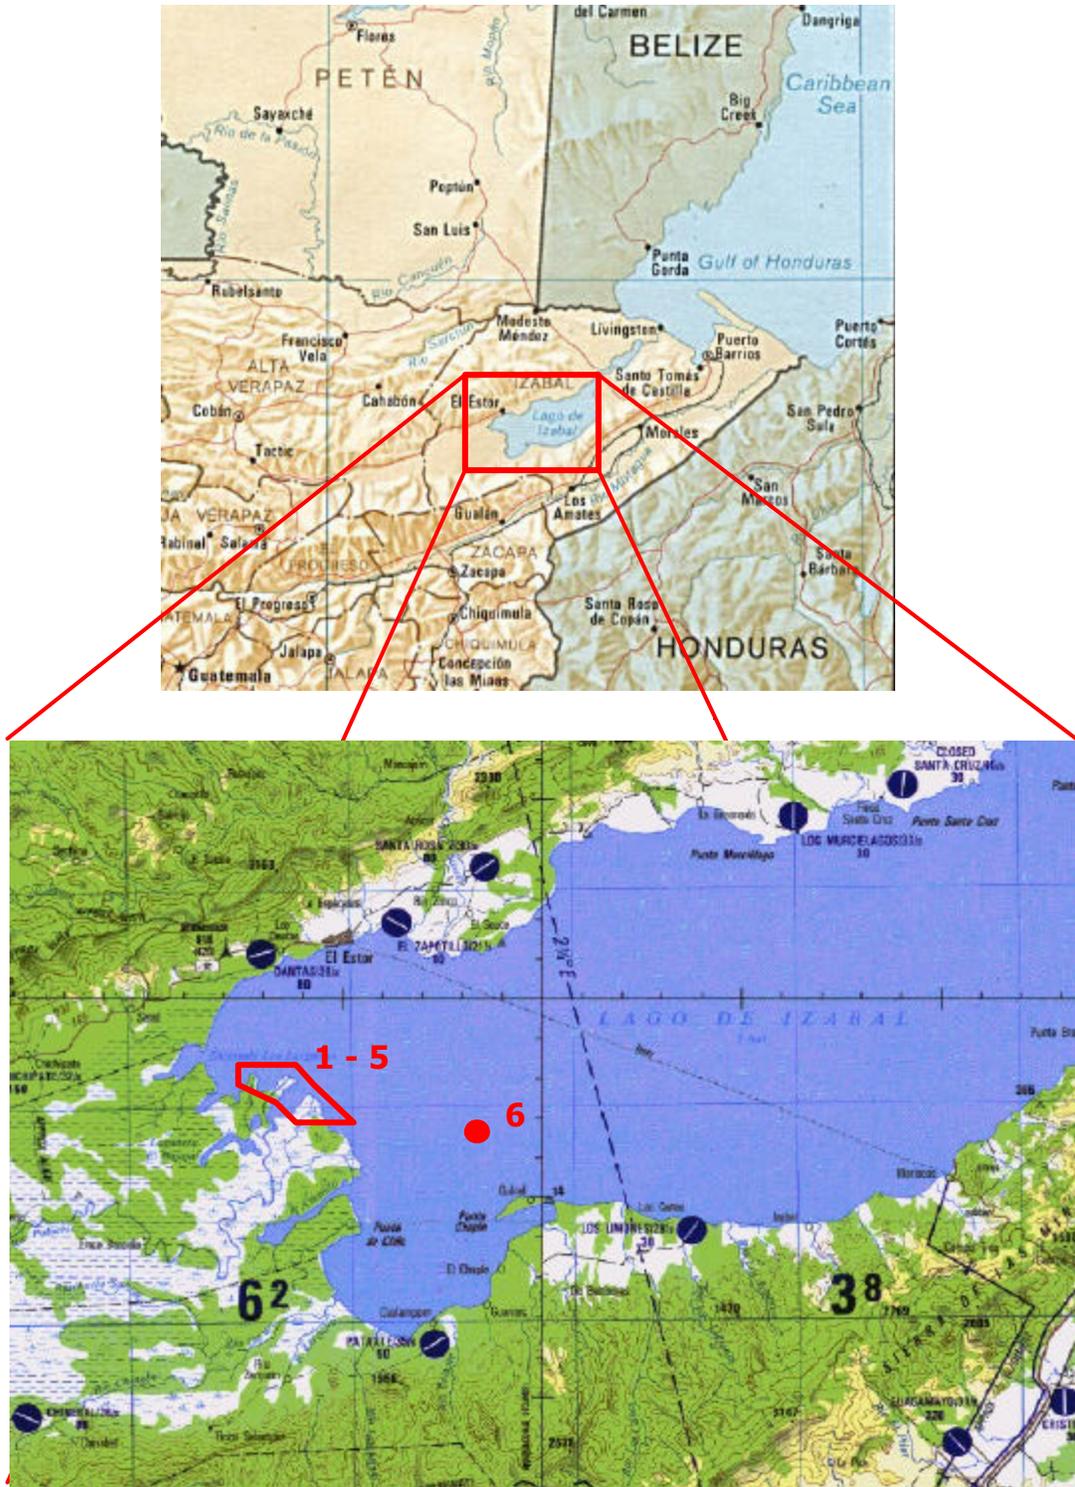
Figure 1. Eastern Guatemala and Lake Izabal. Map inset (bottom) shows sampling sites around the mouth of the Polochic River (sites 1-5) and central Lake Izabal (site 6).

Lake Izabal (Lago de Izabal; fig. 1) is the largest lake in Guatemala, 45 km in length, with an area of 590 km<sup>2</sup> and a maximum depth of about 17 m. It is an inland lake located in the eastern part of the country, not far (40 km) from the Caribbean coast. The lake is surrounded by mountains (Sierra de las Minas to the south, Sierra de Santa Cruz to the north) and is fed by many streams, the greatest of which is the Rio Polochic, one of the largest streams in the country. The outflow from the lake is via the Rio Dulce, through a smaller lake, La Golfette, and into Bahia de Amatique and the Gulf of Honduras near the town of Livingston.

The Polochic River forms an elongated meandering delta (fig. 1) that stretches out into the lake and the water exits into the lake through two outlets. There is a northeast distributary (fig. 2) and a south distributary (fig. 3). The ground crew began analyses of water conditions at the northeast Polochic distributary channel. A heavy phytoplankton bloom was observed believed to be *Microcystis* sp. based on the colloidal or globular shape (John Burns, St. Johns River Water Management District, oral communication). An apparent increase in sediment load was observed in the river outflow and evidenced by increased visible water turbidity that increased with movement from distal to proximal location at the mouth of the river. This observation was confirmed from the air where a large sediment plume was observed exiting the mouth of the river from both the northeast and south outlets (see figs. 2 and 3). Sediment loads were proportional to the distribution of flow at each exit with the south exit being the greatest.

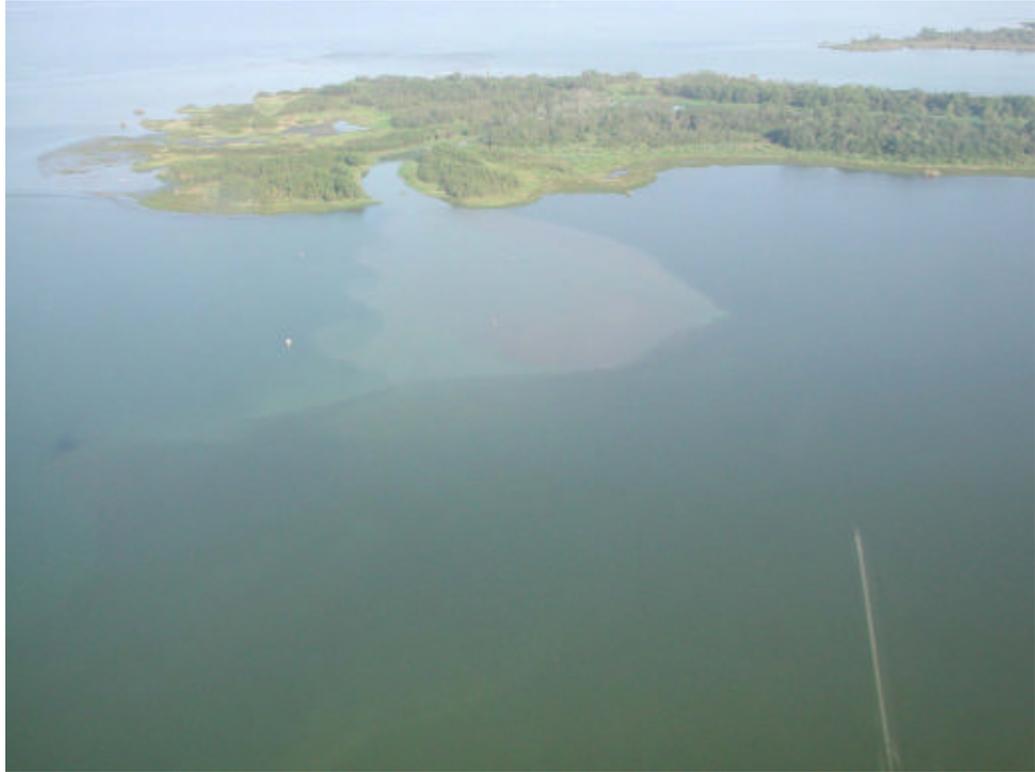
Figure 2. Aerial view of northeast distributary of the Polochic River with visible sediment plume.

At the mouth of the northeast Polochic River distributary a swift current was observed and the water column was turbid and completely mixed throughout (no apparent stratification), and the depth was estimated to be 4 m. No globular phytoplankton were visible in the immediate area, but the water had a green tint. Measured saturated dissolved oxygen concentrations were found throughout the well-mixed water column (table 1).

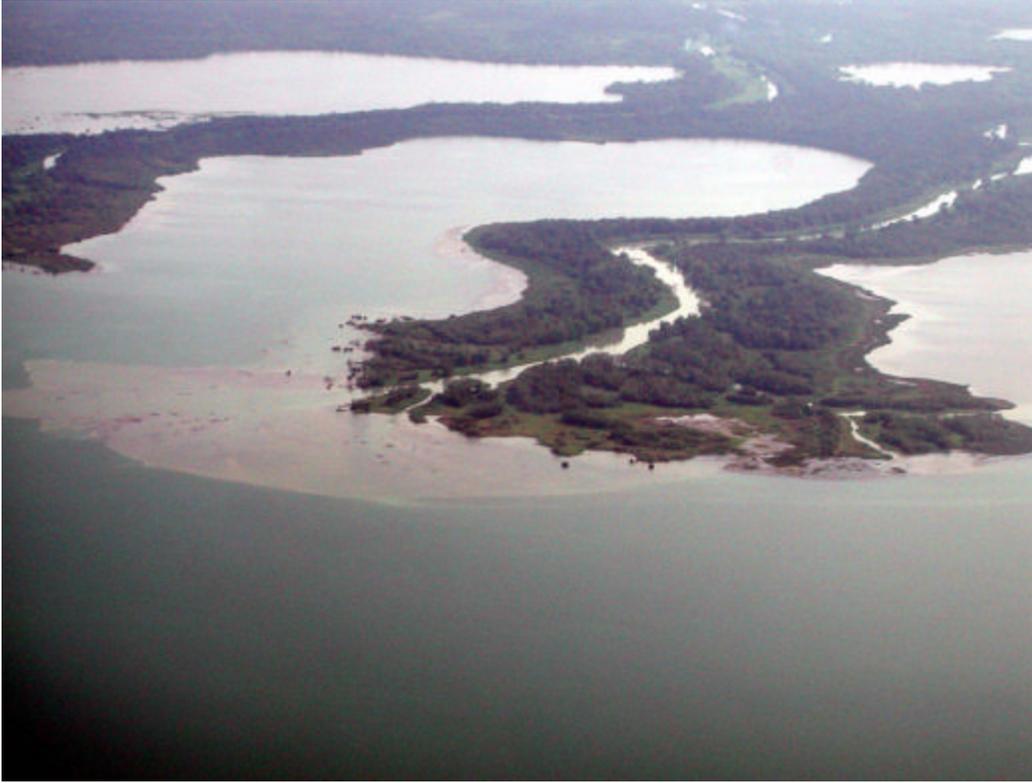
Figure 3. Aerial view of the mouth of the southern distributary of the Polochic River with very large sediment plume visible and numerous outwash splays.

At the mouth of the south Polochic River distributary channel, conditions were similar to what was observed at the northeast distributary, however, the volume of flow was much greater. We observed numerous deltaic “finger” formations throughout the area, which is indicative of large and active sediment deposits originating from the river. Some of these deposits were subaerial; they could have been deposited largely during episodic flood events. At this site we took water quality measurements at 20 cm depth in the water column (see table1).

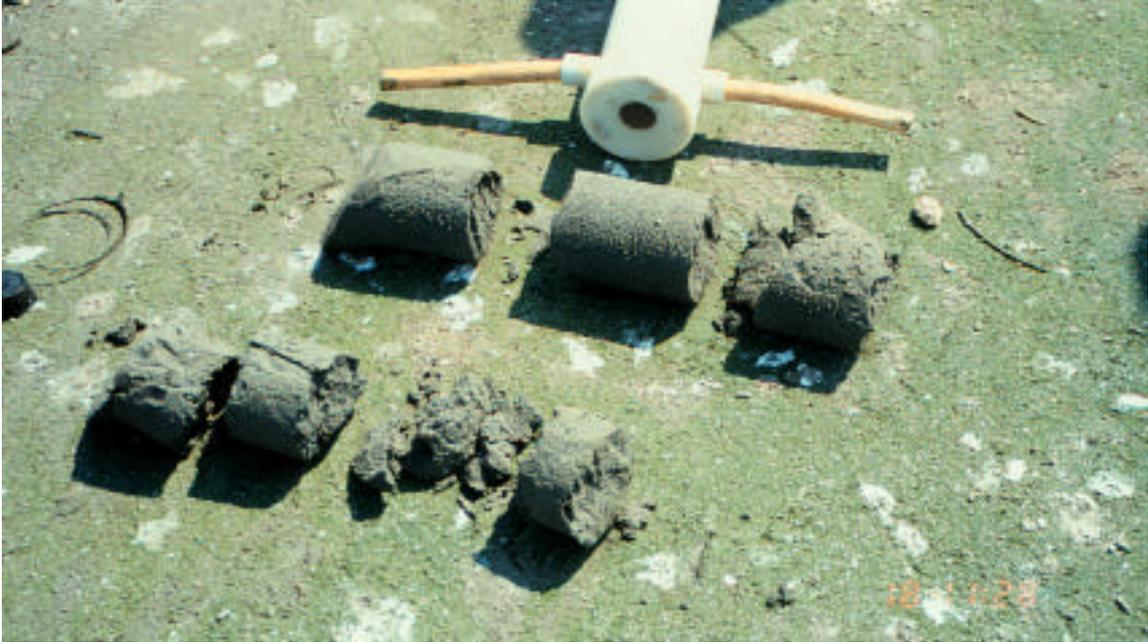
Core 1 (fig. 4) was taken on an exposed subaerial splay located at the mouth of the Polochic River. We observed no apparent layering, and the core was homogeneous silty sand throughout. Core 2 (fig. 5) was taken at 30 cm water depth approximately 20 m from core 1. We observed organic lenses at depths of 43 and 56 cm. We also observed finer silty sand with a lighter color than the rest of the strata at 32-39 cm depth. A third core (no picture available) was taken at a water depth of 56 cm. The total core length was 60 cm, and at 0-14 cm silty sand with mica visible was prevalent. At 14-18 cm oxidation deposits were noted, and at 26-27 cm a layer of fine material was present. At 43 cm we noted a fine brown layer of approximately 0.5 cm thick. The 45-60 cm section of the core was the same as the rest.

Figure 4. Core 1 taken on exposed subaerial splay at the mouth of the Polochic River. There was no apparent layering, and there was homogeneous silty sand throughout.

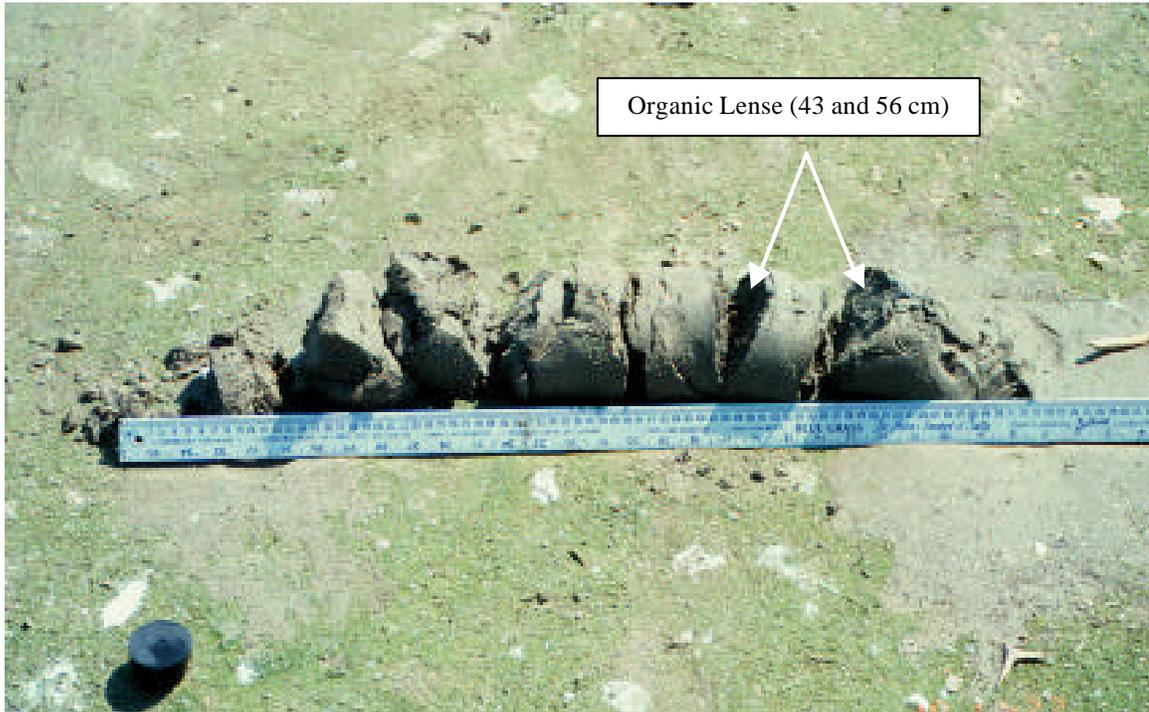
Figure 5. Core 2 was taken at 30 cm water depth approximately 20 m from core 1. We noted organic lenses at 43 and 56 cm. Depth of 32-39 cm was finer silty sand with a lighter color than the rest of the strata.

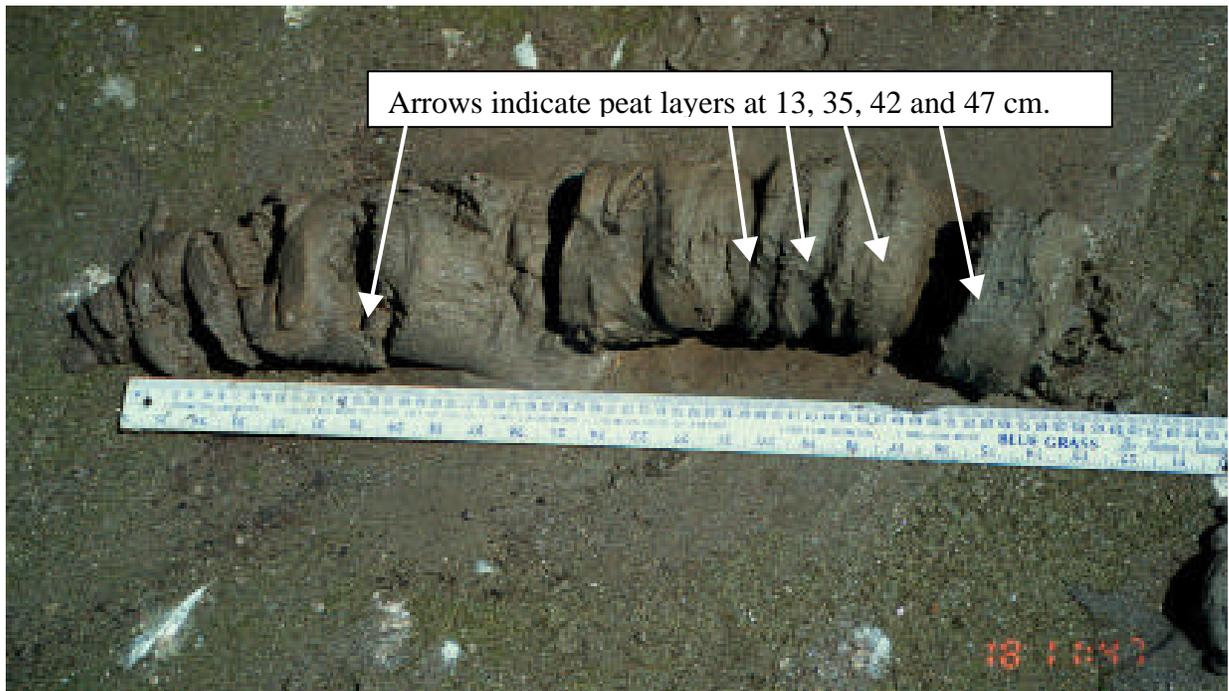
Core 4 (fig. 6) was taken 20 m from the site of core 1 at a water depth of 24 cm. The 0-13 cm section consisted primarily of silty sand. However, we observed 1 cm thick peat layers at numerous depths, including those at 13, 33, 35, 42 and 47 cm. At 42-45 cm depth, a darker reduced layer appeared. Core 5 (fig. 7) was similar to core 4 in that it was taken 20 m from the site of core 1 at a water depth of 24 cm. Again, we observed 1-cm thick peat layers at 24, 27, 30, 34, 43, and 49 cm depth.

Figure 6. Core 4 taken 20 m from the site of core 1 at a water depth of 24 cm. The first 13 cm were silty sand, and we observed 1-cm thick peat layers at depths of 13, 33, 35, 42, and 47 cm. There was a darker, reduced layer at 42-45 cm.

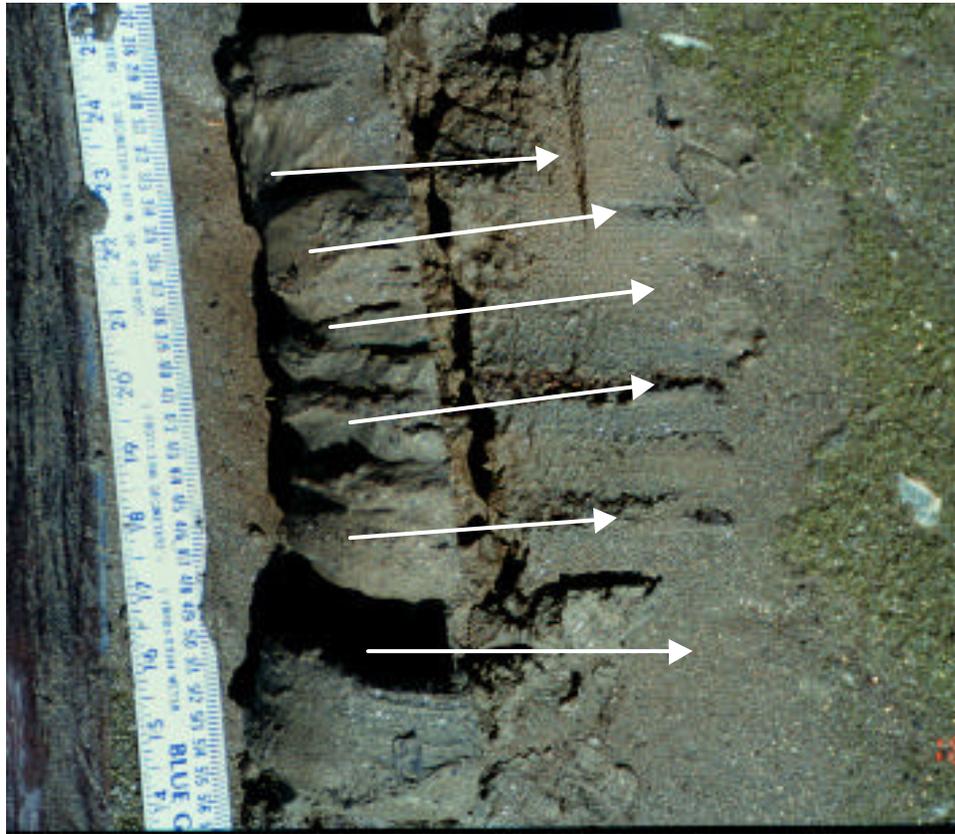
Arrows indicate peat layers at 24, 27, 30, 34, 43 and 49 cm depths

Figure 7. Core 5 taken 20 cm from site of core 1 at water depth of 24 cm (similar to core 4). Peat layers 1-cm thick were observed at 24, 27, 30, 34, 43, 49 cm depths.

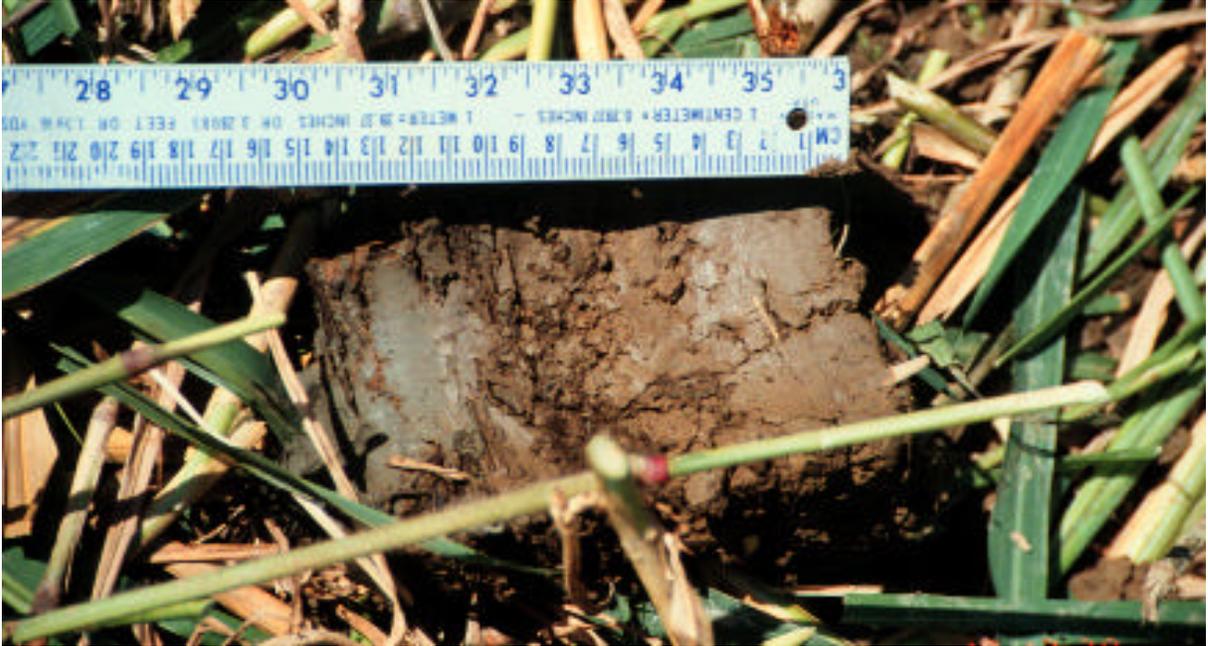
Core 6 (fig. 8) was taken upstream from the mouth of the Polochic River at a point 1 km from Site 1. The sample was taken 20 m inland from the shoreline at a site flooded only during extreme high water events. No obvious hurricane impact signature was observed; the top 10 cm layer was oxidized sandy clay, and the 10 cm layer below that was reduced gray clay.

Figure 8. The core 6 site was located upstream from the mouth of Polochic River at a point 1 km from site 1. The sample was taken 20 m on shore at a site flooded only during extreme high water events. No obvious hurricane impact signature was observed. The top 10 cm layer was oxidized sandy clay and the 10 cm layer below that was reduced gray clay.

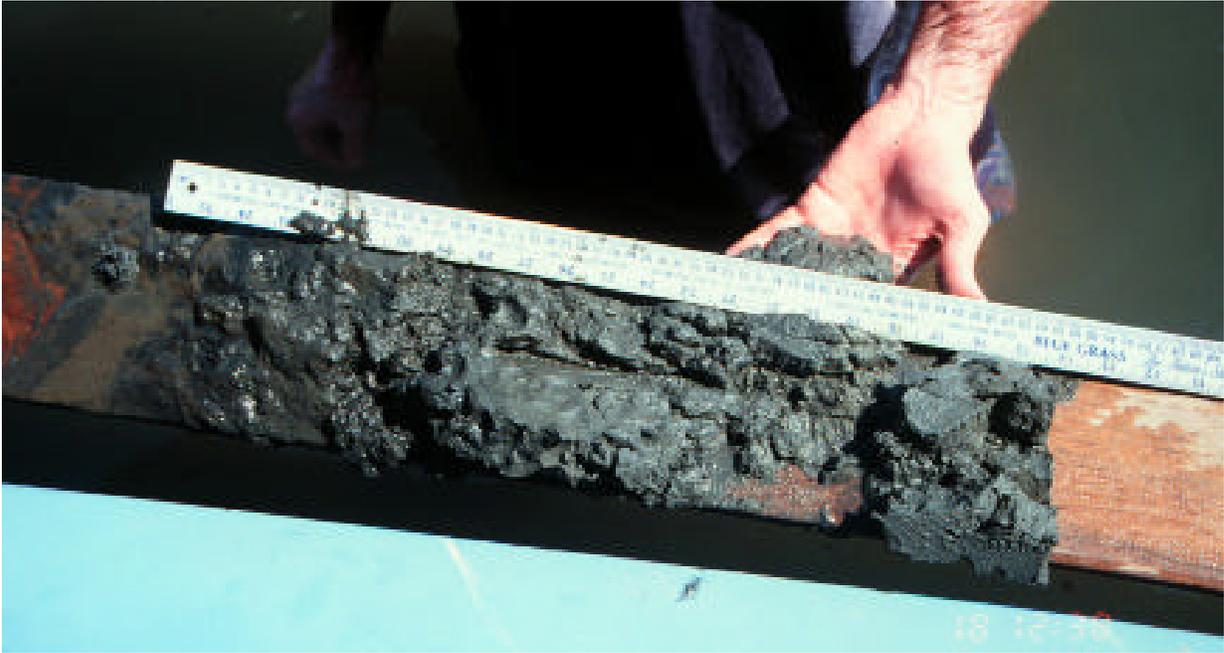
Core 7 (fig. 9) was taken east of the Polochic River where water column profiles were taken on the previous day (15° 29' 14.7" N, 89° 21' 49.4"W). The depth of the water was approximately 52 cm, and the top 0-18 cm consisted of silty ooze. We observed sandy silt for 18-53 cm depth. An eighth core (no picture available) was taken 10 m

Figure 9. Core 7 site east of Polochic River where water column profile was recorded on the previous day (Location:  $15^{\circ} 29' 14.7''$  N,  $89^{\circ} 21' 49.4''$  W). Depth of water was 52 cm, and at 0-18 cm, sediment was silty ooze. At depths of 18-33 and 33-53 cm, layers were sandy silt.
